Rehabbing a Pair of Egg-Shaped Sewers in Winnipeg with Sliplining

BY ADAM BRAUN AND ANDY SHERWIN ON JULY 15, 2016

When two egg-shaped sewers exhibited signs of advanced structural distress, city officials in Winnipeg, Manitoba, turned to trenchless rehabilitation methods for a solution.

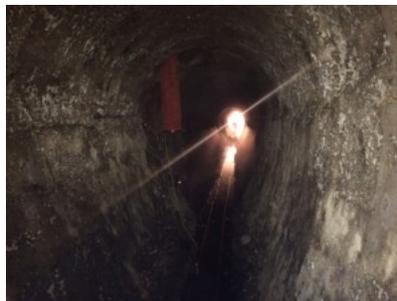
Sade Canada based out of Quebec City mobilized to Winnipeg to access both Trunk Sewers and complete pre-manufacturing surveys. This was completed manually, by taking measurements every 1m of the height and width of the sewer.

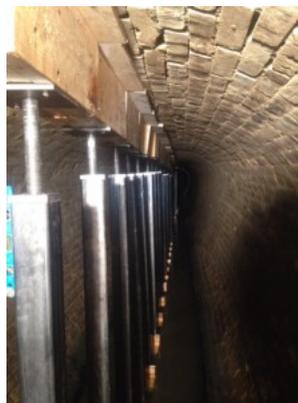
The crown of the sewer, approximately 15m (50ft) from the downstream manhole, had settled/dropped approximately 70mm (3 in) requiring temporary bracing to be installed.

On Jan. 22, the contractor performed a pre-lining CCTV inspection, immediately prior to the insertion of the initial GRP panels. Three days later, the contractor attempted to install the first liner on Selkirk Avenue, only to find that the crown of the sewer – approximately 15 m from the downstream manhole – had settled precluding installation of the prefabricated GRP panels. Based on the pre-design inspection the sewer had settled approximately 70 mm in the past 6 months. This meant that the GRP panels no longer fit through the downstream area and that the sewer was potentially in a state of imminent failure, hence not safe to work in.

Due to the presence of high voltage power cables external excavation was not possible and any stabilization or rehabilitation would need to be trenchless in nature. In order to prevent collapse of the sewer, it was then determined that the best course of action was to temporarily brace the crown in the failing area. In order to permit installation of the pre-manufactured GRP panels. The soil above the pipe was reinforced with grouted spiles, permitting removal of the temporary bracing, removal of the sewer's existing crown, and placement of a layer of shotcrete. The shotcrete stabilization restored the host pipe to near its original dimension, created a safe working environment, and permitted installation of the original GRP panels.

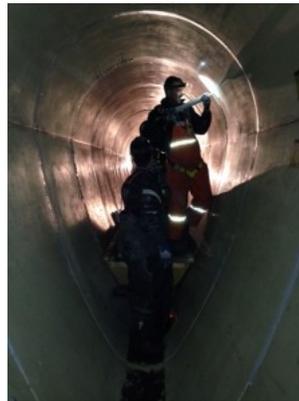
Workers inspect a completed section of the sewer.
